Technical Report CHL-97-13  
July 1997

*Monitoring Completed Navigation Projects Program*

## **Monitoring of Harbor Improvements at St. Paul Harbor, St. Paul Island, Alaska**

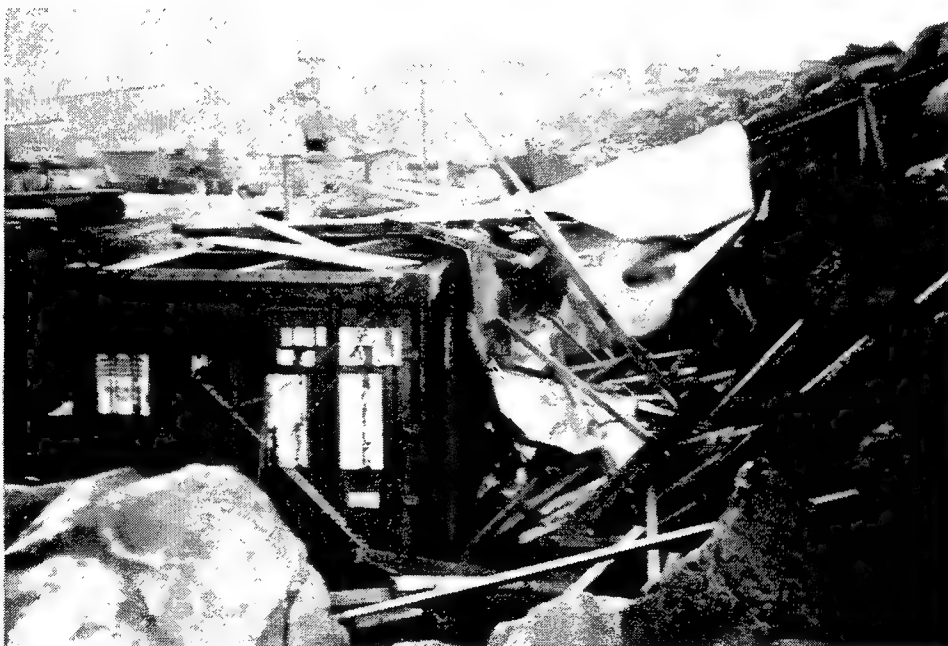
Figure 22. Collapsed apron resulting from 3 November 1994 storm

Wave overtopping rates of 1.7 l/sec/m (0.022 cfs/ft) were calculated from the container in the lee of the main breakwater during the 3-hr period prior to the collapse of the container apron on 3 November 1994. As mentioned previously, as much as 50 percent of the overtopping waves were not collected due to spray and "overshooting" of the container during the storm. Therefore, the actual rates are not quantifiable. It was also noted that significant volumes of water were reaching the road as a result of waves passing through the rubble-mound structure. These values could not be quantified with the equipment setup that was onsite. Waves passing through the structure and overtopping from this storm were obviously unacceptable since they resulted in washing out of the road in the lee of the breakwater. Since incident wave conditions were not known and overtopping rates could not be quantified for this storm event, no attempt was made to correlate overtopping results with the two-dimensional model study results or guidance provided in the *Shore Protection Manual*.

for 2.6-m (8.5-ft) waves indicate a runup value between 4.9 and 5.2 m (16 and 17 ft) would occur (based on *Shore Protection Manual* predictions); however, massive overtopping actually occurred that resulted in destruction of the apron. Local forecasts indicated winds of 50 knots and seas of 9.1 m (30 ft) on 3 November 1994. Based on these comparisons, the hindcast data appear to have under-estimated wave conditions at the site. As stated earlier, in general, trends indicated larger waves occurred with higher runup values and wave overtopping, but absolute values of the wave heights generated by the hindcast model appeared low.

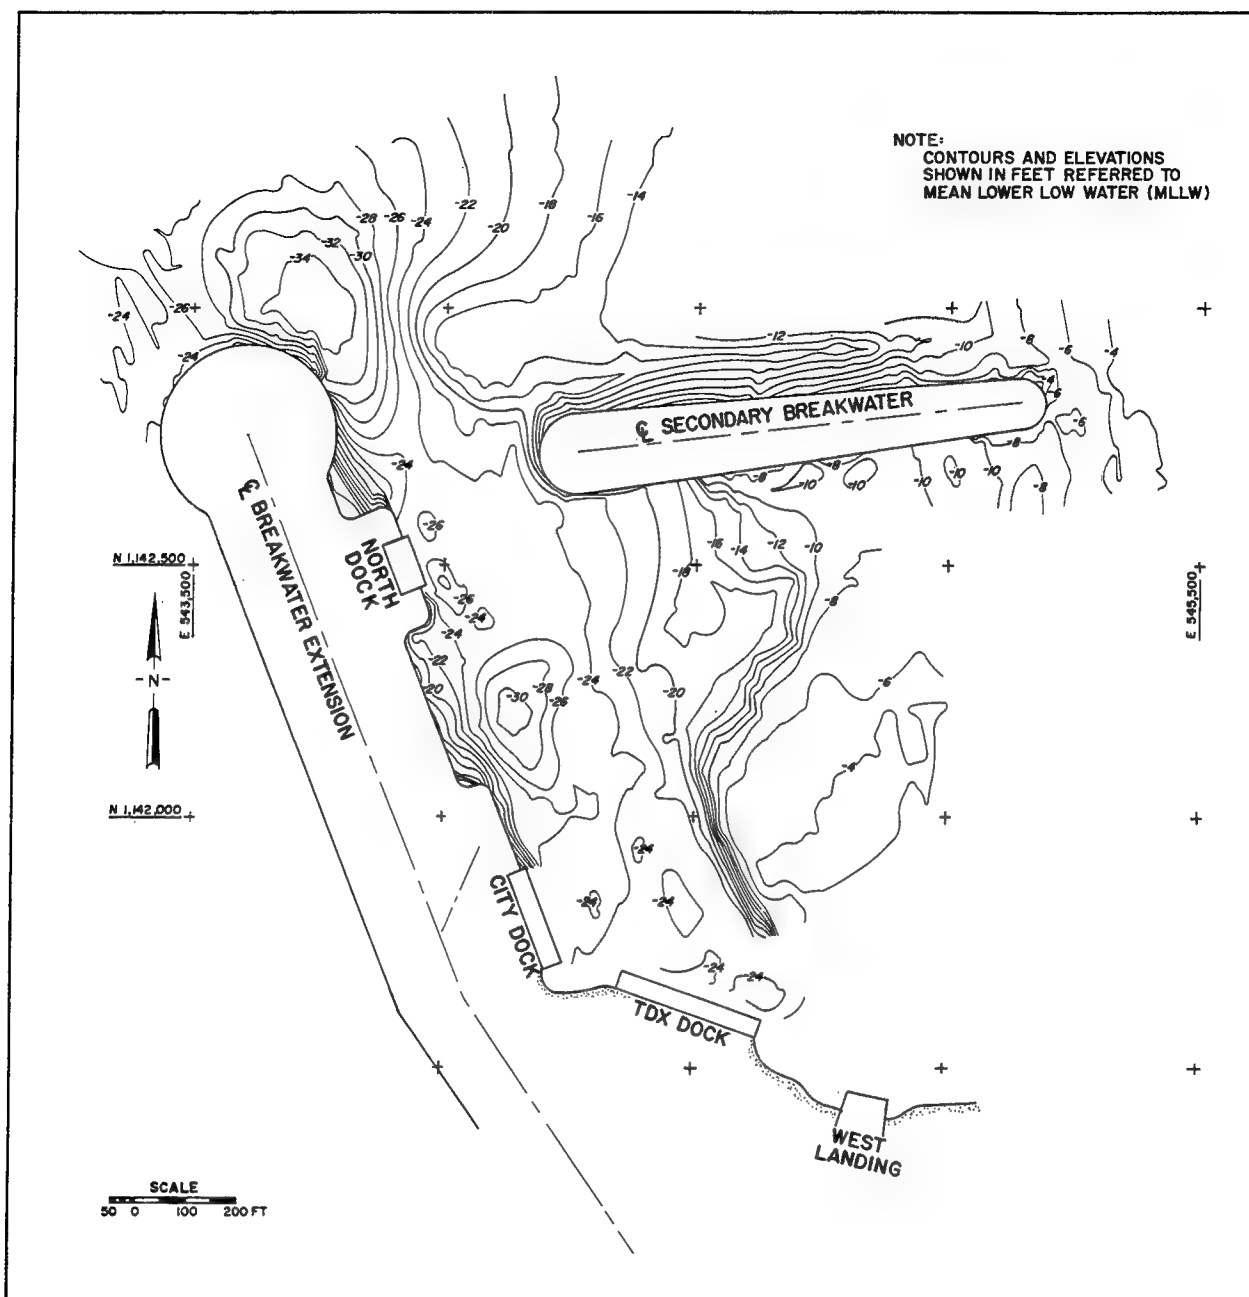
Figure 25. Bathymetry at St. Paul Harbor, August 1992

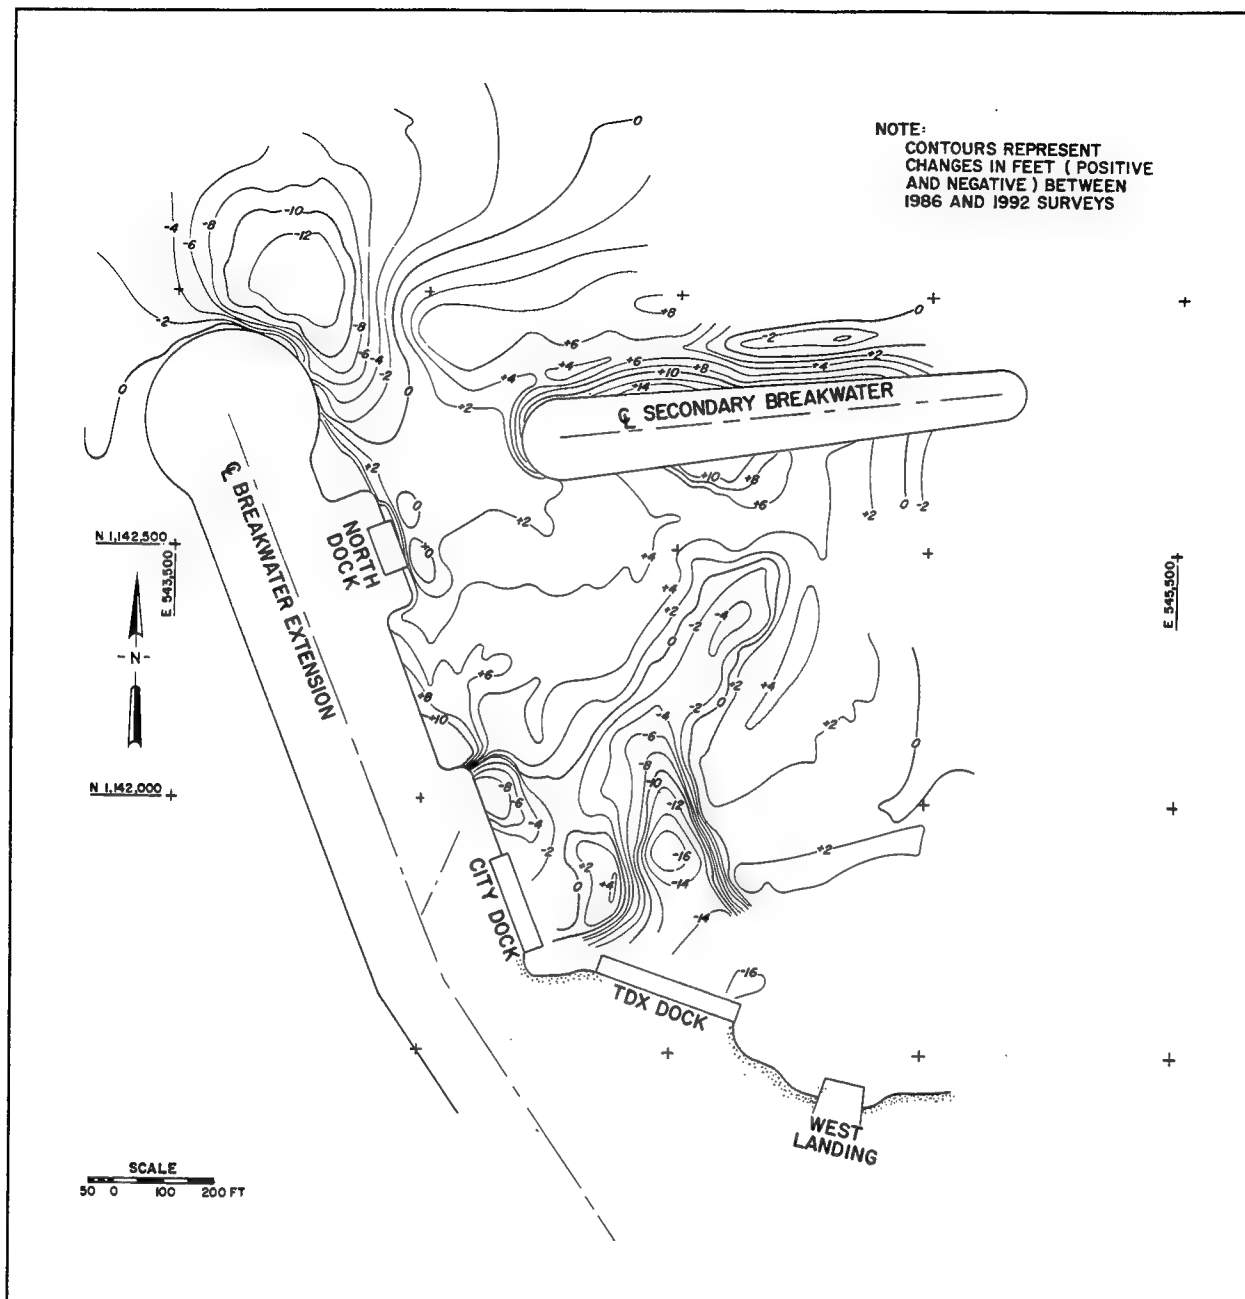
Contours of bathymetric changes that occurred between the September 1986 and the August 1992 surveys are shown in Figure 26. These contours show fill and scour conditions in and adjacent to the harbor. The figure shows a 3.7-m (12-ft) scour hole had formed adjacent to the head of the outer breakwater. In addition, accretion up to 4.3 m (14 ft) had occurred adjacent to the north side of the detached breakwater. An underwater spit had formed north of the west end of the detached structure and has the potential to migrate across the channel. Accretion of 3 m (10 ft) occurred adjacent to the south side of the detached breakwater which suggested sediment may be moving through the structure. Inside the harbor, the scour north of the TDX dock was due to dredging by local interests. Also, the scour hole formed by the original 229-m-long (750-ft-long) outer breakwater appeared to be filling. This may be due to settlement of suspended sediment caused by vessel prop wash, dredging operations, and/or hydrodynamic conditions. The August 1992 survey did not include bathymetry in the area in the lee of the east end of the detached breakwater and adjacent to the shoreline inside the harbor.

Figure 26. Contours of bathymetric changes between September 1986 and August 1992 surveys

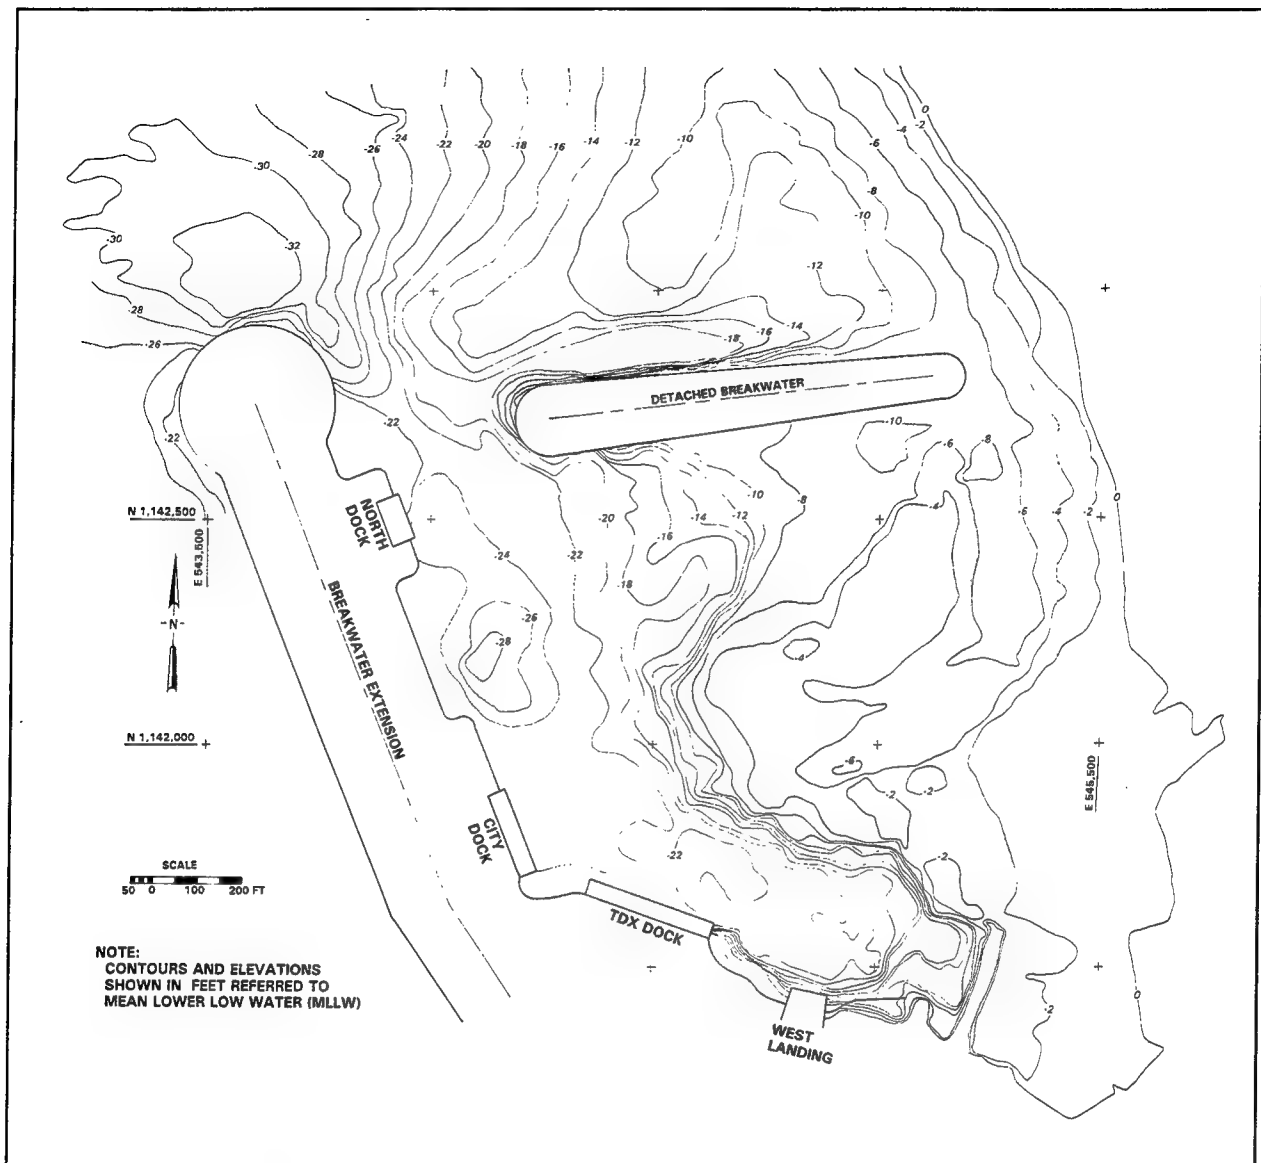
Bathymetric data obtained during the July 1995 survey are shown in Figure 27. The scour hole that had formed at the head of the structure in the August 1992 survey appears to have slightly filled in and shifted slightly west around the head of the structure. To this point, the scour hole has not impacted the stability of the head of the breakwater. The contours north of and adjacent to the detached breakwater are similar to the 1992 survey. To this point, the underwater spit has not had any negative impact on navigation. Local interests dredged an area inside the harbor

Figure 27. Bathymetry at St. Paul Harbor, July 1995

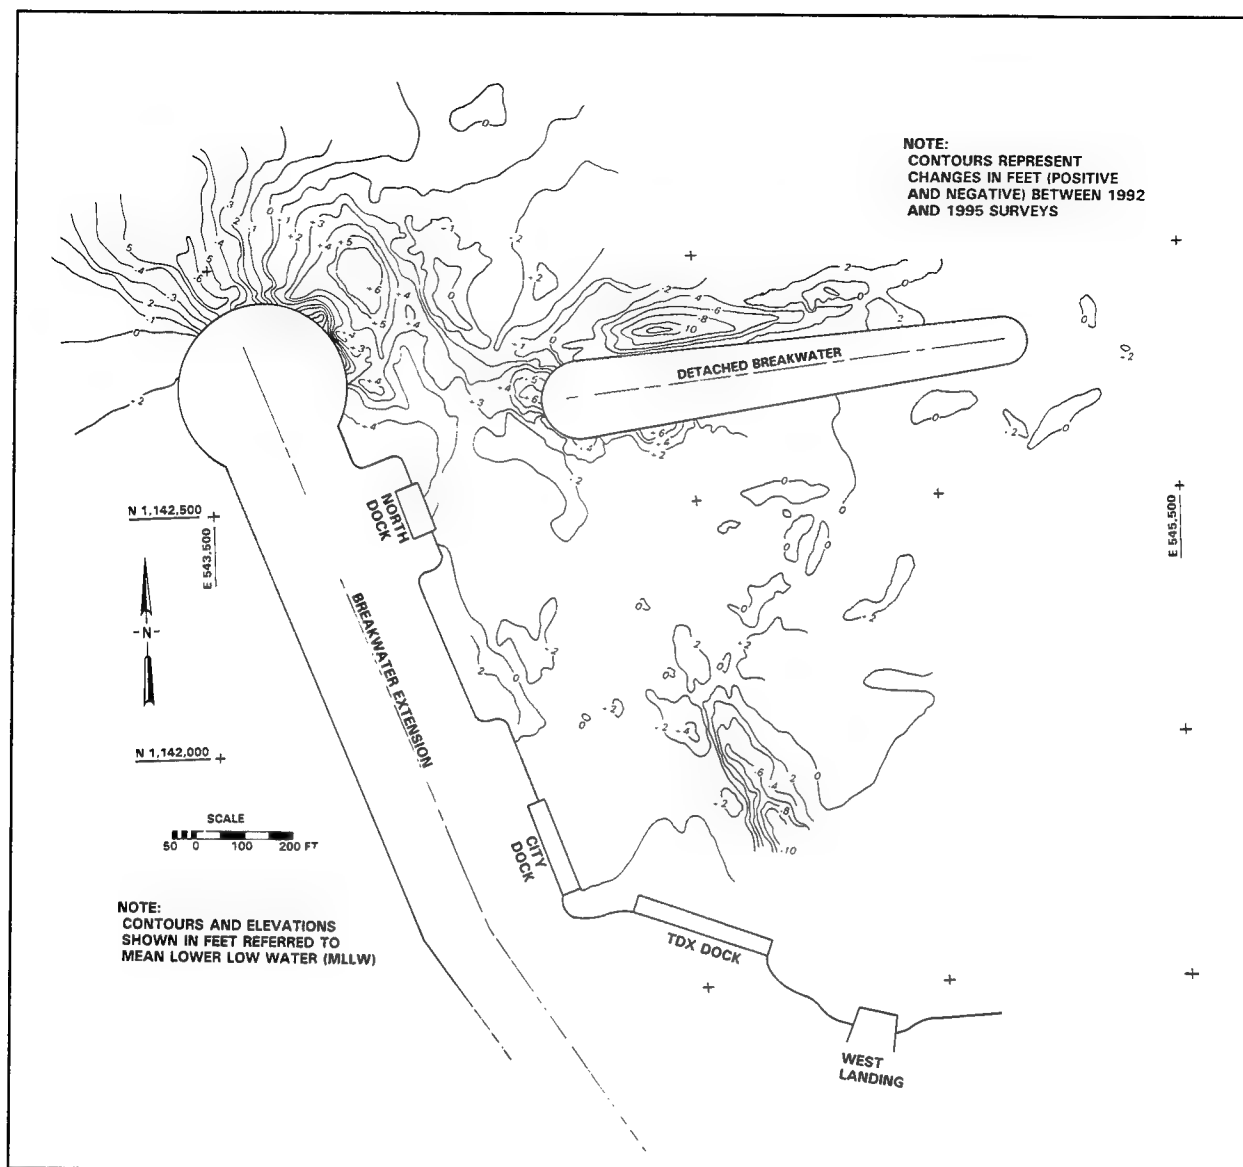
Contours of bathymetric changes that occurred between the August 1992 and July 1995 surveys are shown in Figure 28. The figure shows that the old (1992) scour hole location has filled in about 1.8 m (6 ft), with a 1.8-m (6-ft) cut at the new location to the west. The accretion immediately adjacent to the north side of the detached breakwater in 1992 had subsided by 3 m (10 ft). Not shown on the figure (due to lack of data in 1992), however, is a slight shift in the underwater spit north

of its old location with accretion observed. Accretion of 1.8 m (6 ft) had occurred at the seaward head of the detached breakwater. Cut and fill inside the harbor north of the TDX dock was probably related to the dredging operations at West Landing by local interests.

Figure 28. Contours of bathymetric changes between August 1992 and July 1995 surveys

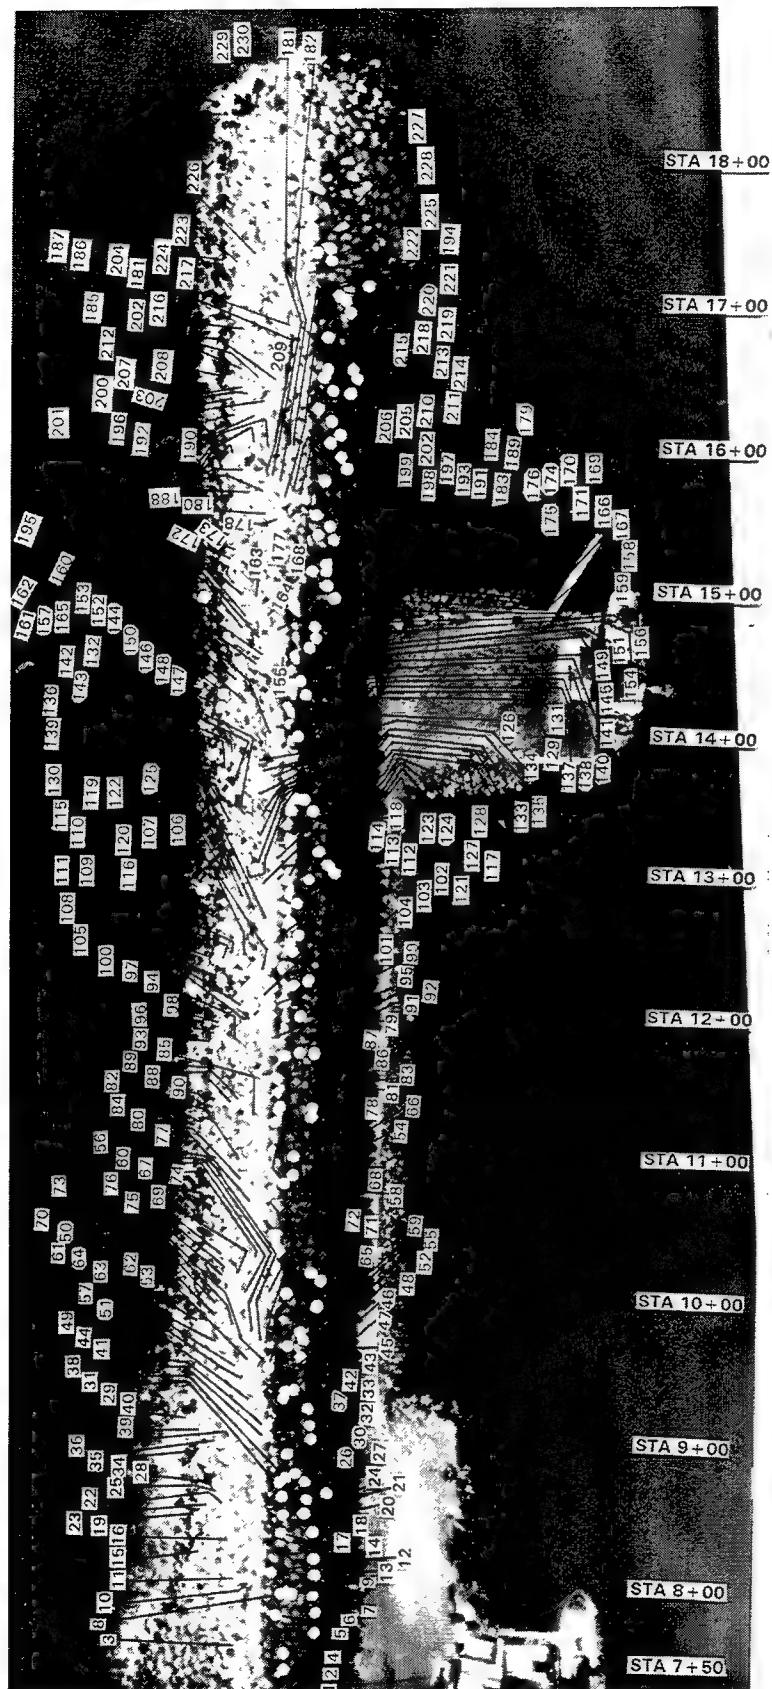
A survey of broken/cracked armor stone above the waterline on the 320-m-long (1,050-ft-long) St. Paul Harbor outer main breakwater was conducted four times during the monitoring period. Surveys were conducted in July 1993, June 1994, June 1995, and June 1996. During the inspections, each broken armor stone was identified and photographed, and its approximate location relative to breakwater station and distance from a baseline was recorded. The baseline was the approximate centerline of the structure. Armor stones with hairline cracks were not counted; only those that were cracked all the way through. A geological assessment of the broken stone was conducted during the June 1995 survey.

Figure 39. Approximate locations of broken/cracked armor stone on outer breakwater during June 1996 survey

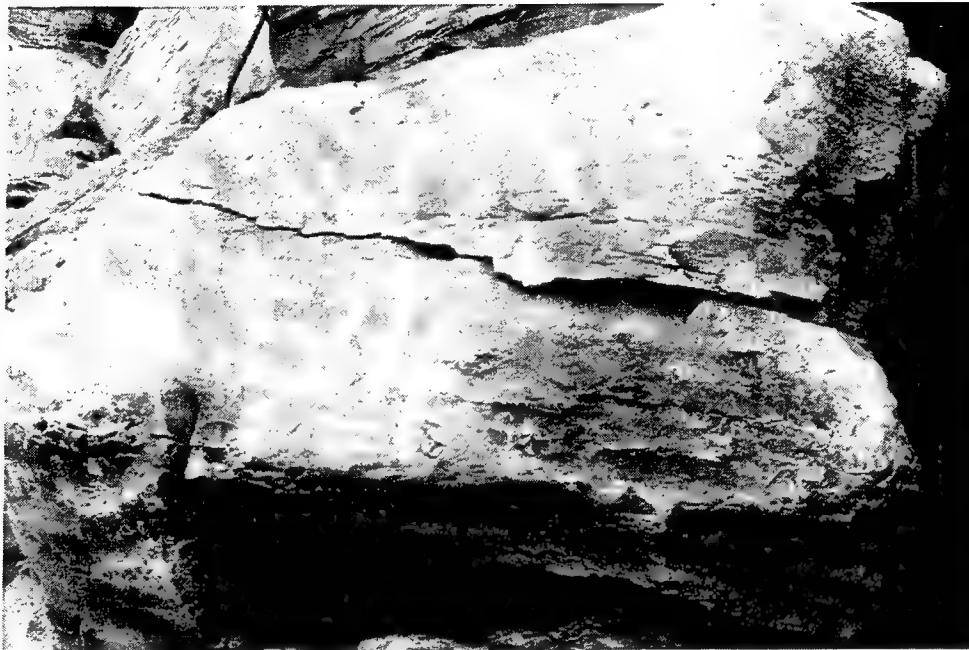
Figure 40. View of broken armor stone on St. Paul Harbor breakwater (station 10+21)

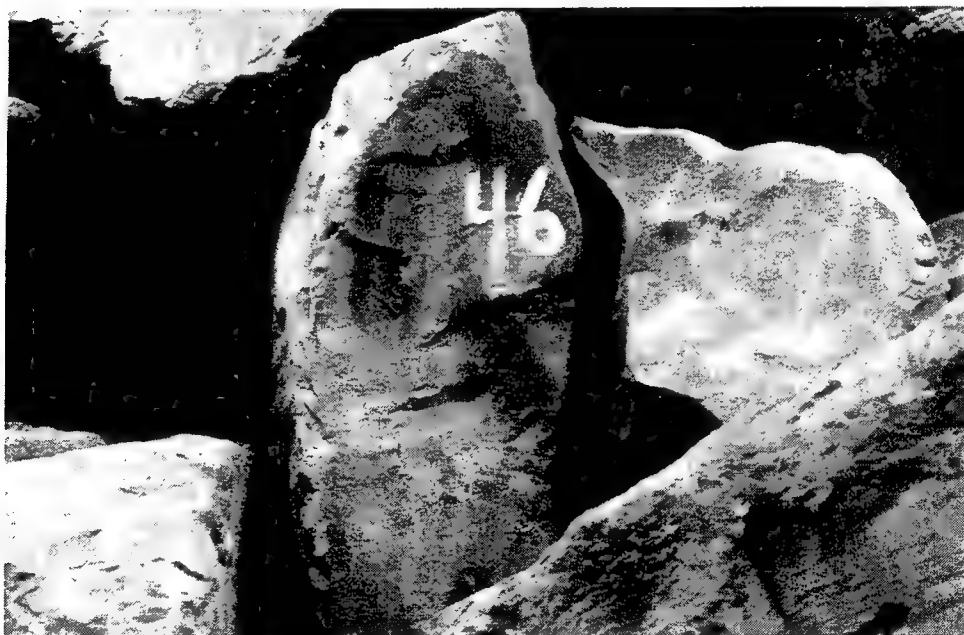
Figure 41. View of broken armor stone on St. Paul Harbor breakwater (station 11+78)

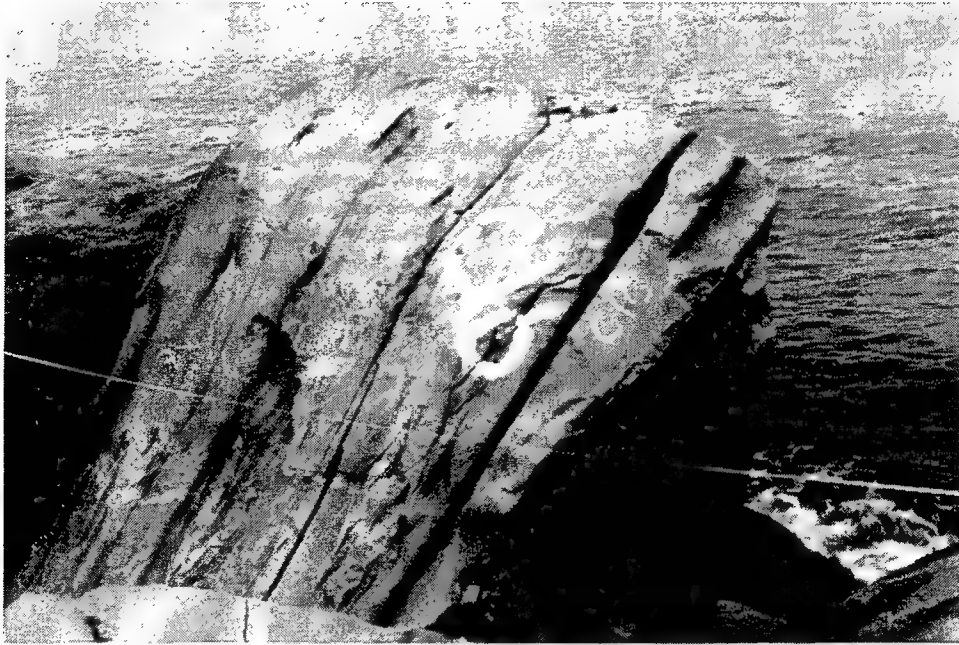
Figure 42. View of broken armor stone on St. Paul Harbor breakwater  
(station 11+87)

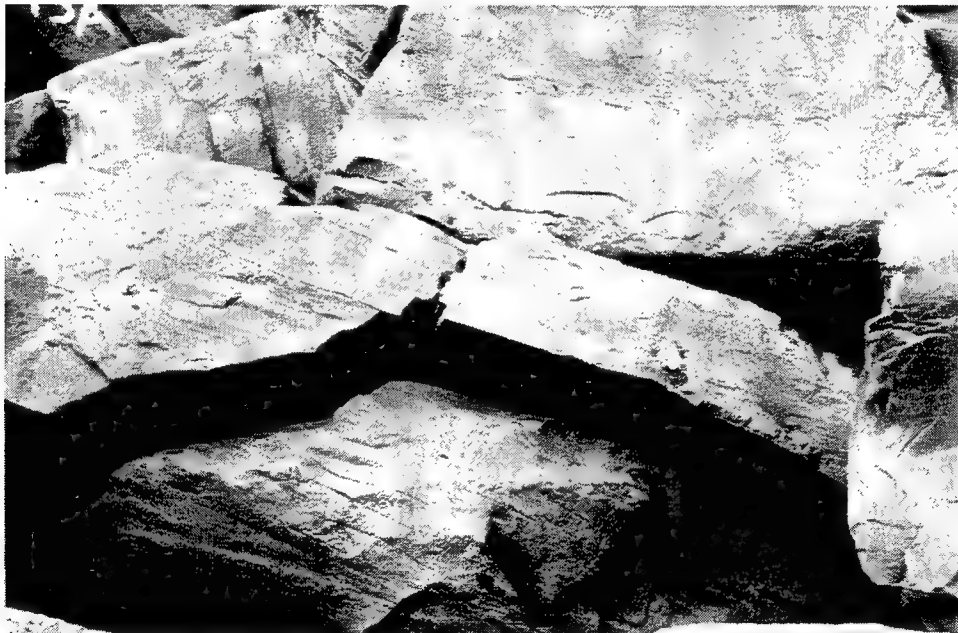
Figure 43. View of broken armor stone on St. Paul Harbor breakwater  
(station 17+34)
